This TSI Service Bulletin replaces TSI Service Bulletin 215-002, "Camshaft Wear, D12, D12A, D12B, D12C" (11.2001), publication no. PV776-TSP160575.

Date	Group	No.	Supp.	Page
3.2004	<b>215</b>	<b>002</b>		1(2)

## Camshaft Wear, Check D12, D12A, D12B, D12C

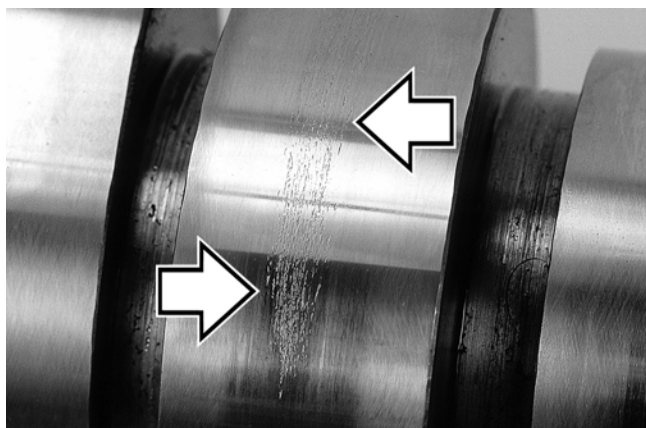
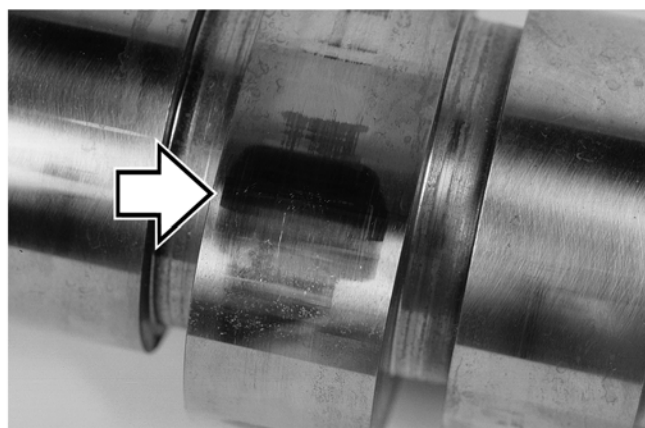
Fig. 2: Camshafts with acceptable wear

Surface irregularities may appear on VOLVO engine camshaft lobes in normal operation. This does not mean that the camshaft must be replaced. These marks do not adversely affect the engine's performance nor the durability of the engine or any of its components.

Fig. 2: Camshafts with acceptable wear, page 2 provides examples of camshaft lobes exhibiting this condition. These camshafts may be reused.

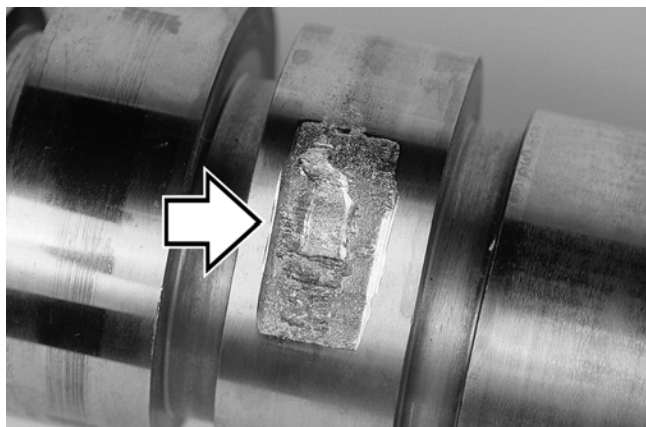
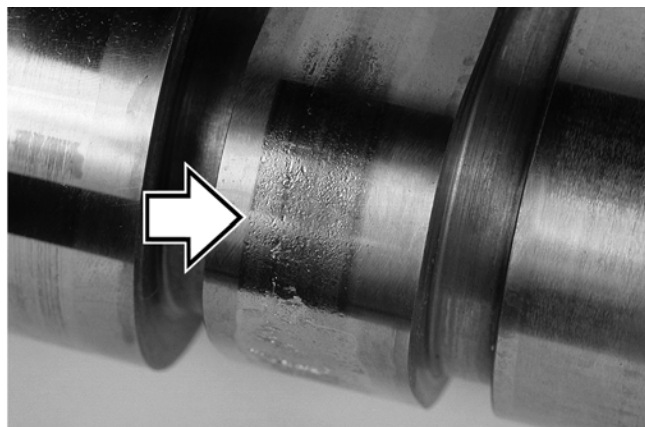
Fig. 3: Camshafts with unacceptable wear

Fig. 3: Camshafts with unacceptable wear, page 2 provides examples of lobes exhibiting unacceptable wear and deterioration. These camshafts and the rocker arms corresponding to the worn lobes must be replaced.

**Note:** If there is any measurable wear, such as shown in Fig. 3: Camshafts with unacceptable wear, page 2, the camshaft should be replaced.
