Volvo Trucks North America, Inc.

Date Group No. Supp. Page 12.2001 **215 008** 1(2)

Intermediate Gear Tightening Torque TD122, TD123

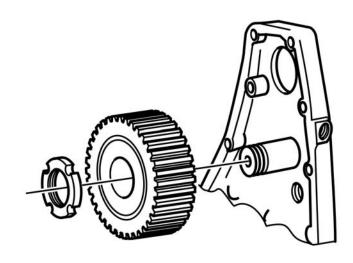
Fig. 1: installing intermediate gear

A higher torque is specified for the nut for the intermediate gear on TD122 and TD123 engines.

- A new nut is used to install the intermediate gear. It should be installed with the flat surface against the ball bearing. This nut no longer uses a washer and lock ring. (See Fig. 1: installing intermediate gear, page 2.)
- The new nut should be torque-tightened to 190 ± 10
 Nm (140 ± 8 ft-lb) using pin spanner 9996682. (See Fig. 2: 9996682, pin spanner, page 2.)
